Insurance Appraisal  
East Village Master Homeowners Association  
3000 East Village Drive  
Venice, Florida 34293

**RE: East Village Master Homeowners Association  
Insurance Appraisal**

**August 1, 2022**

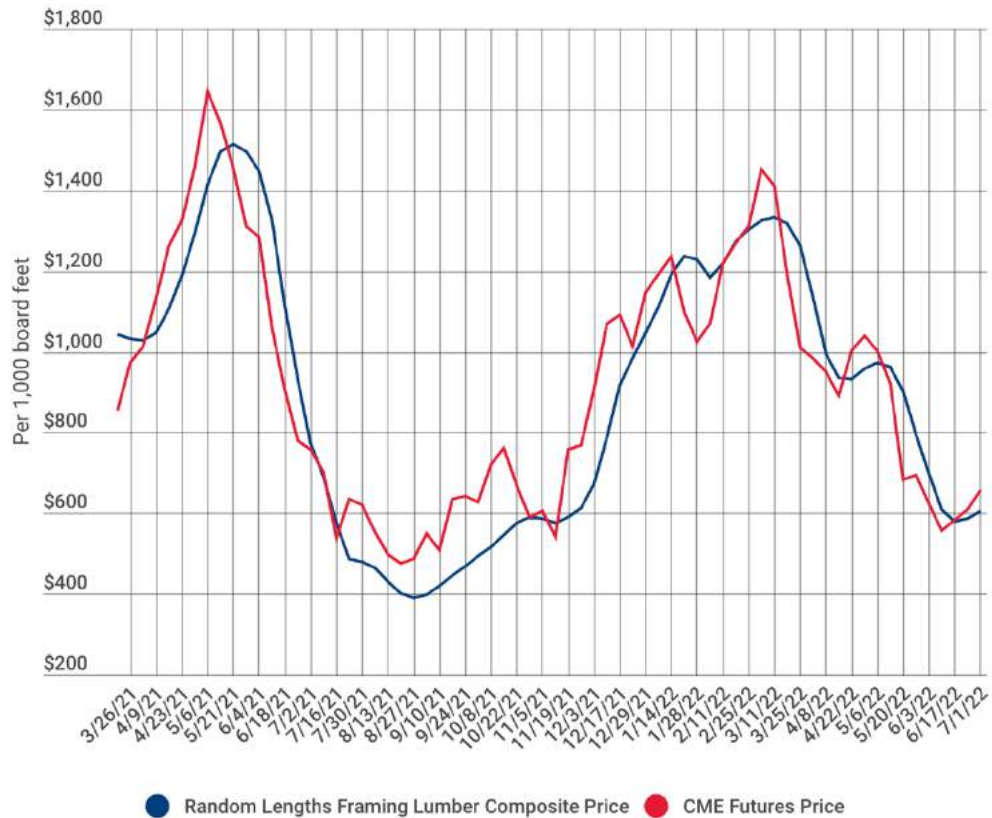
The following chart is taken from the National Association of Home Builders' (NAHB) Producer Price Index (PPI) released by the Bureau of Labor Statistics. The dramatic increase in softwood lumber effects all buildings but is especially impactful for wood frame buildings (ISO 1). However, all types of wood are affected, e.g., wood for millwork, cabinetry, framing wood, roof trusses, roof sheathing, etc.

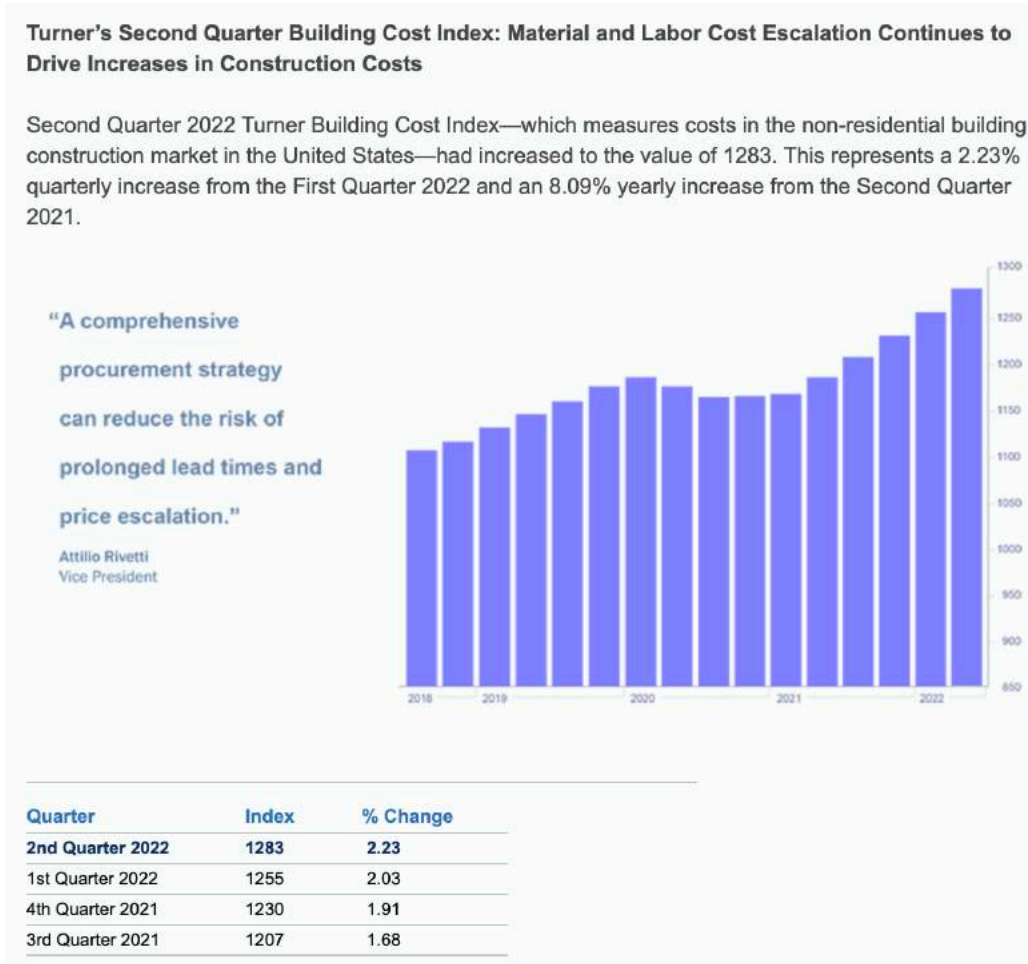
The Turner Construction index (overall construction cost and activity) shows 2.23% increase from the 1st quarter of 2022 to the 2nd quarter of 2022.

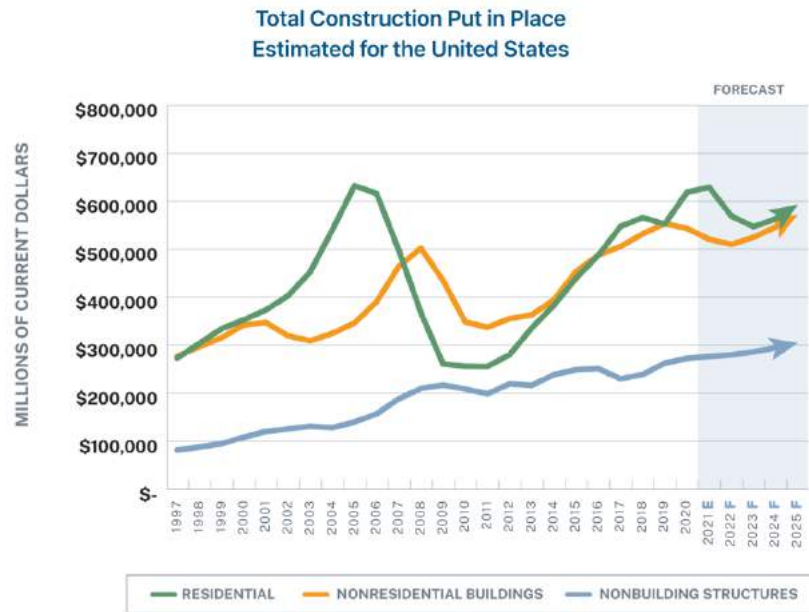
The following chart is taken from the U.S. Markets Construction Overview with an outlook up to 2025, published by the FMI Corporation, it shows the permanent increase in construction put in place and with that underlines the increasing cost for material and labor:
